Navajo Abandoned Uranium Mine Site Screen Report

Section 13 AUM Site

Navajo AUM Eastern Region

May 2009

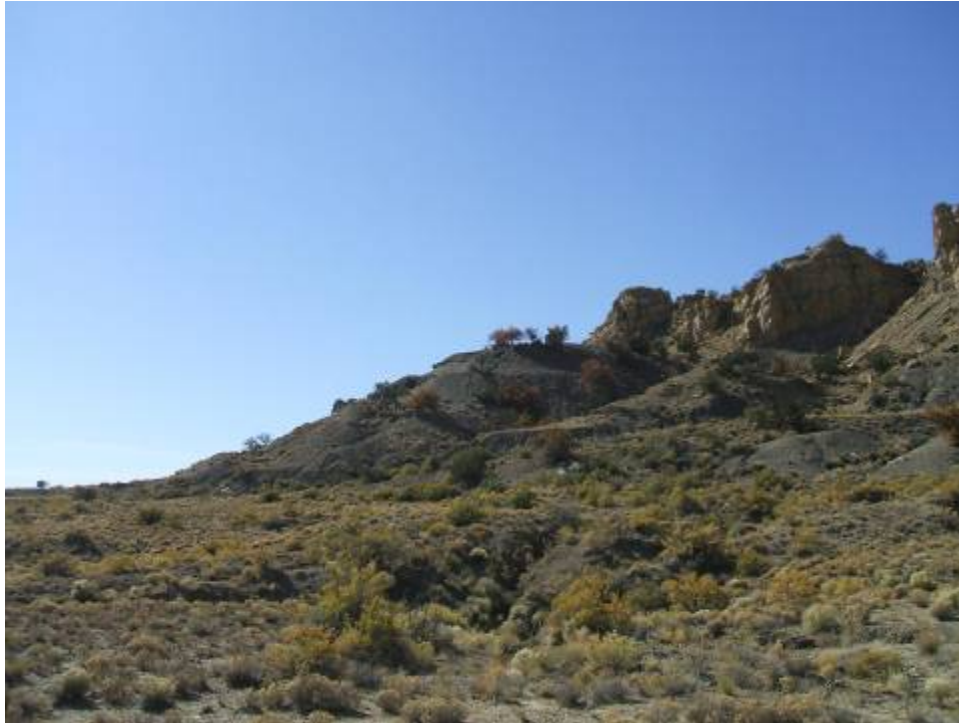
Photo 1. Section 13 mine site hill side, towards the west

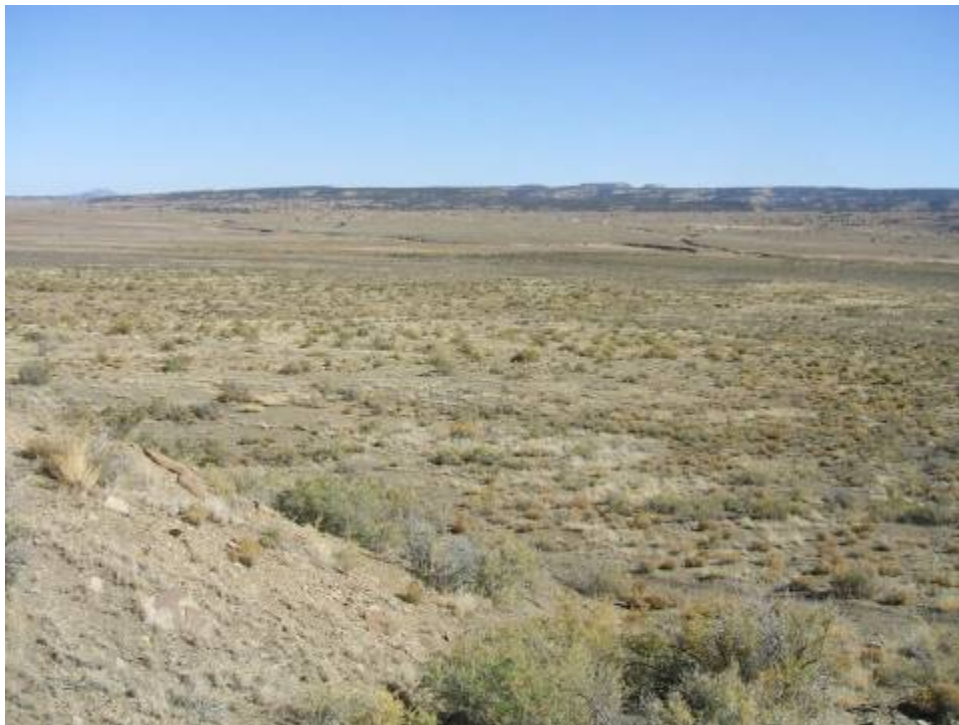
Photo 2. Section 13 mine site flat area, towards the south

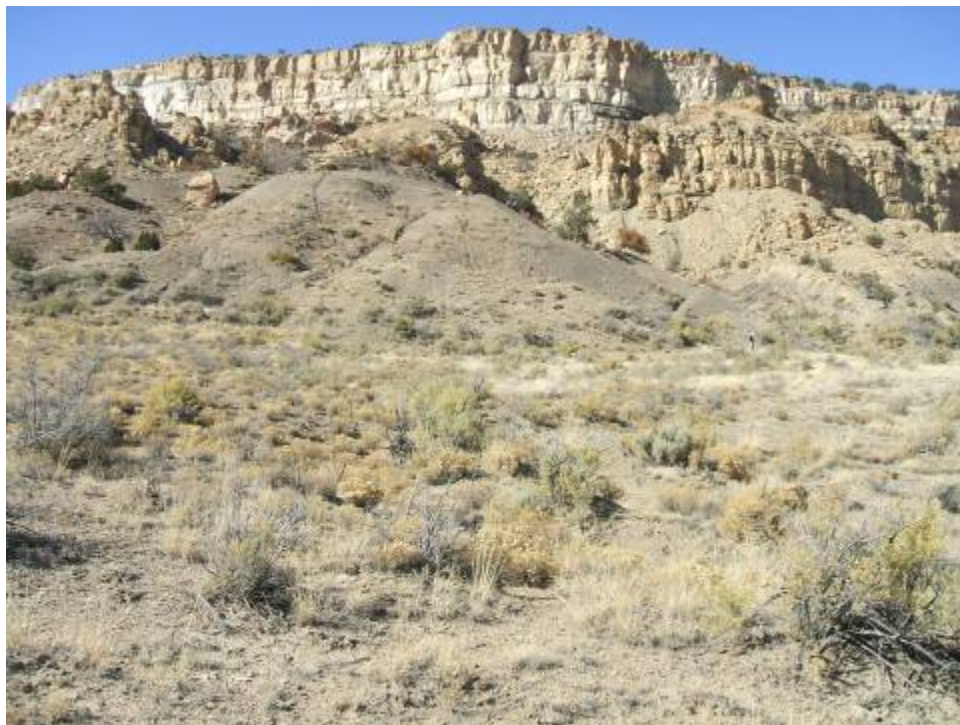
Reclamation status of the mine site is currently unknown. No visible signs of reclamation were observed. A monitoring well was observed within the northern portion of the site. No adits, waste piles, or other mine features were observed during the site visit.

Photo 3. Section 13 mine site, towards the north

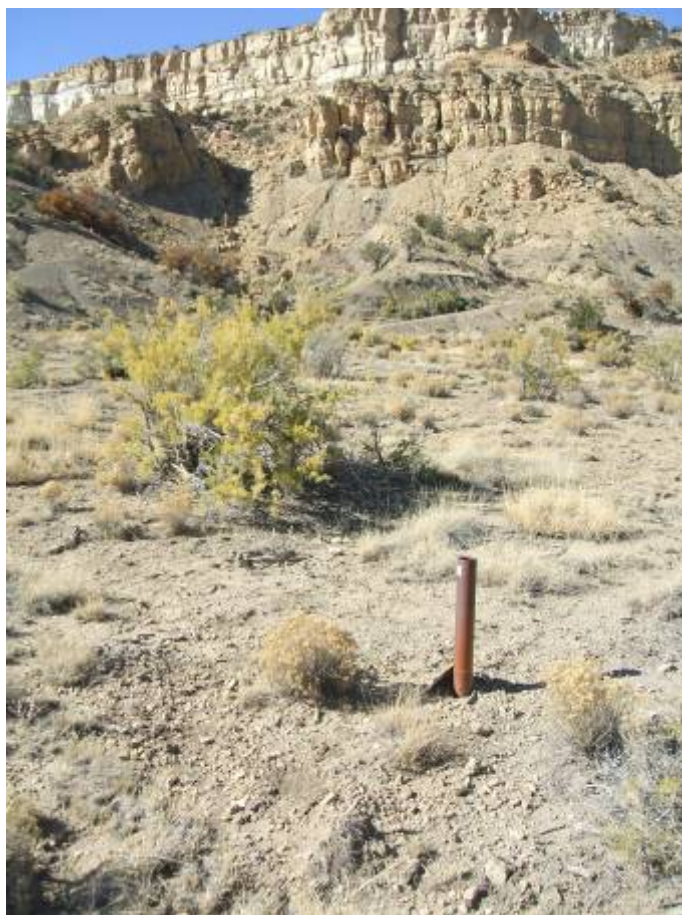
Photo 4. Section 13 mine site well, towards the north

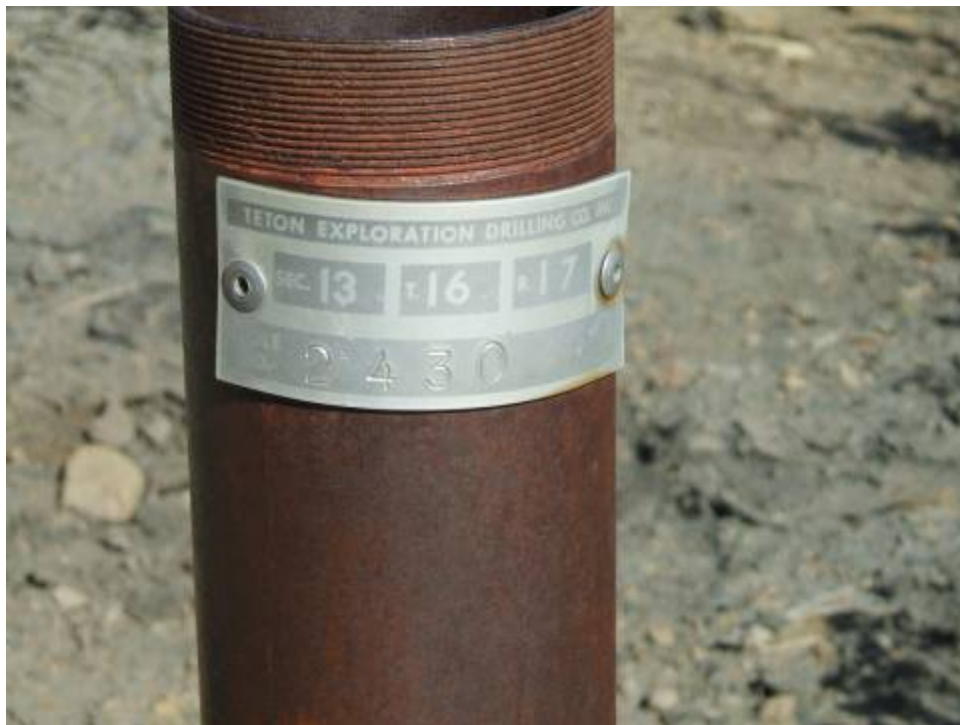
Photo 5. Section 13 mine site well, towards the east

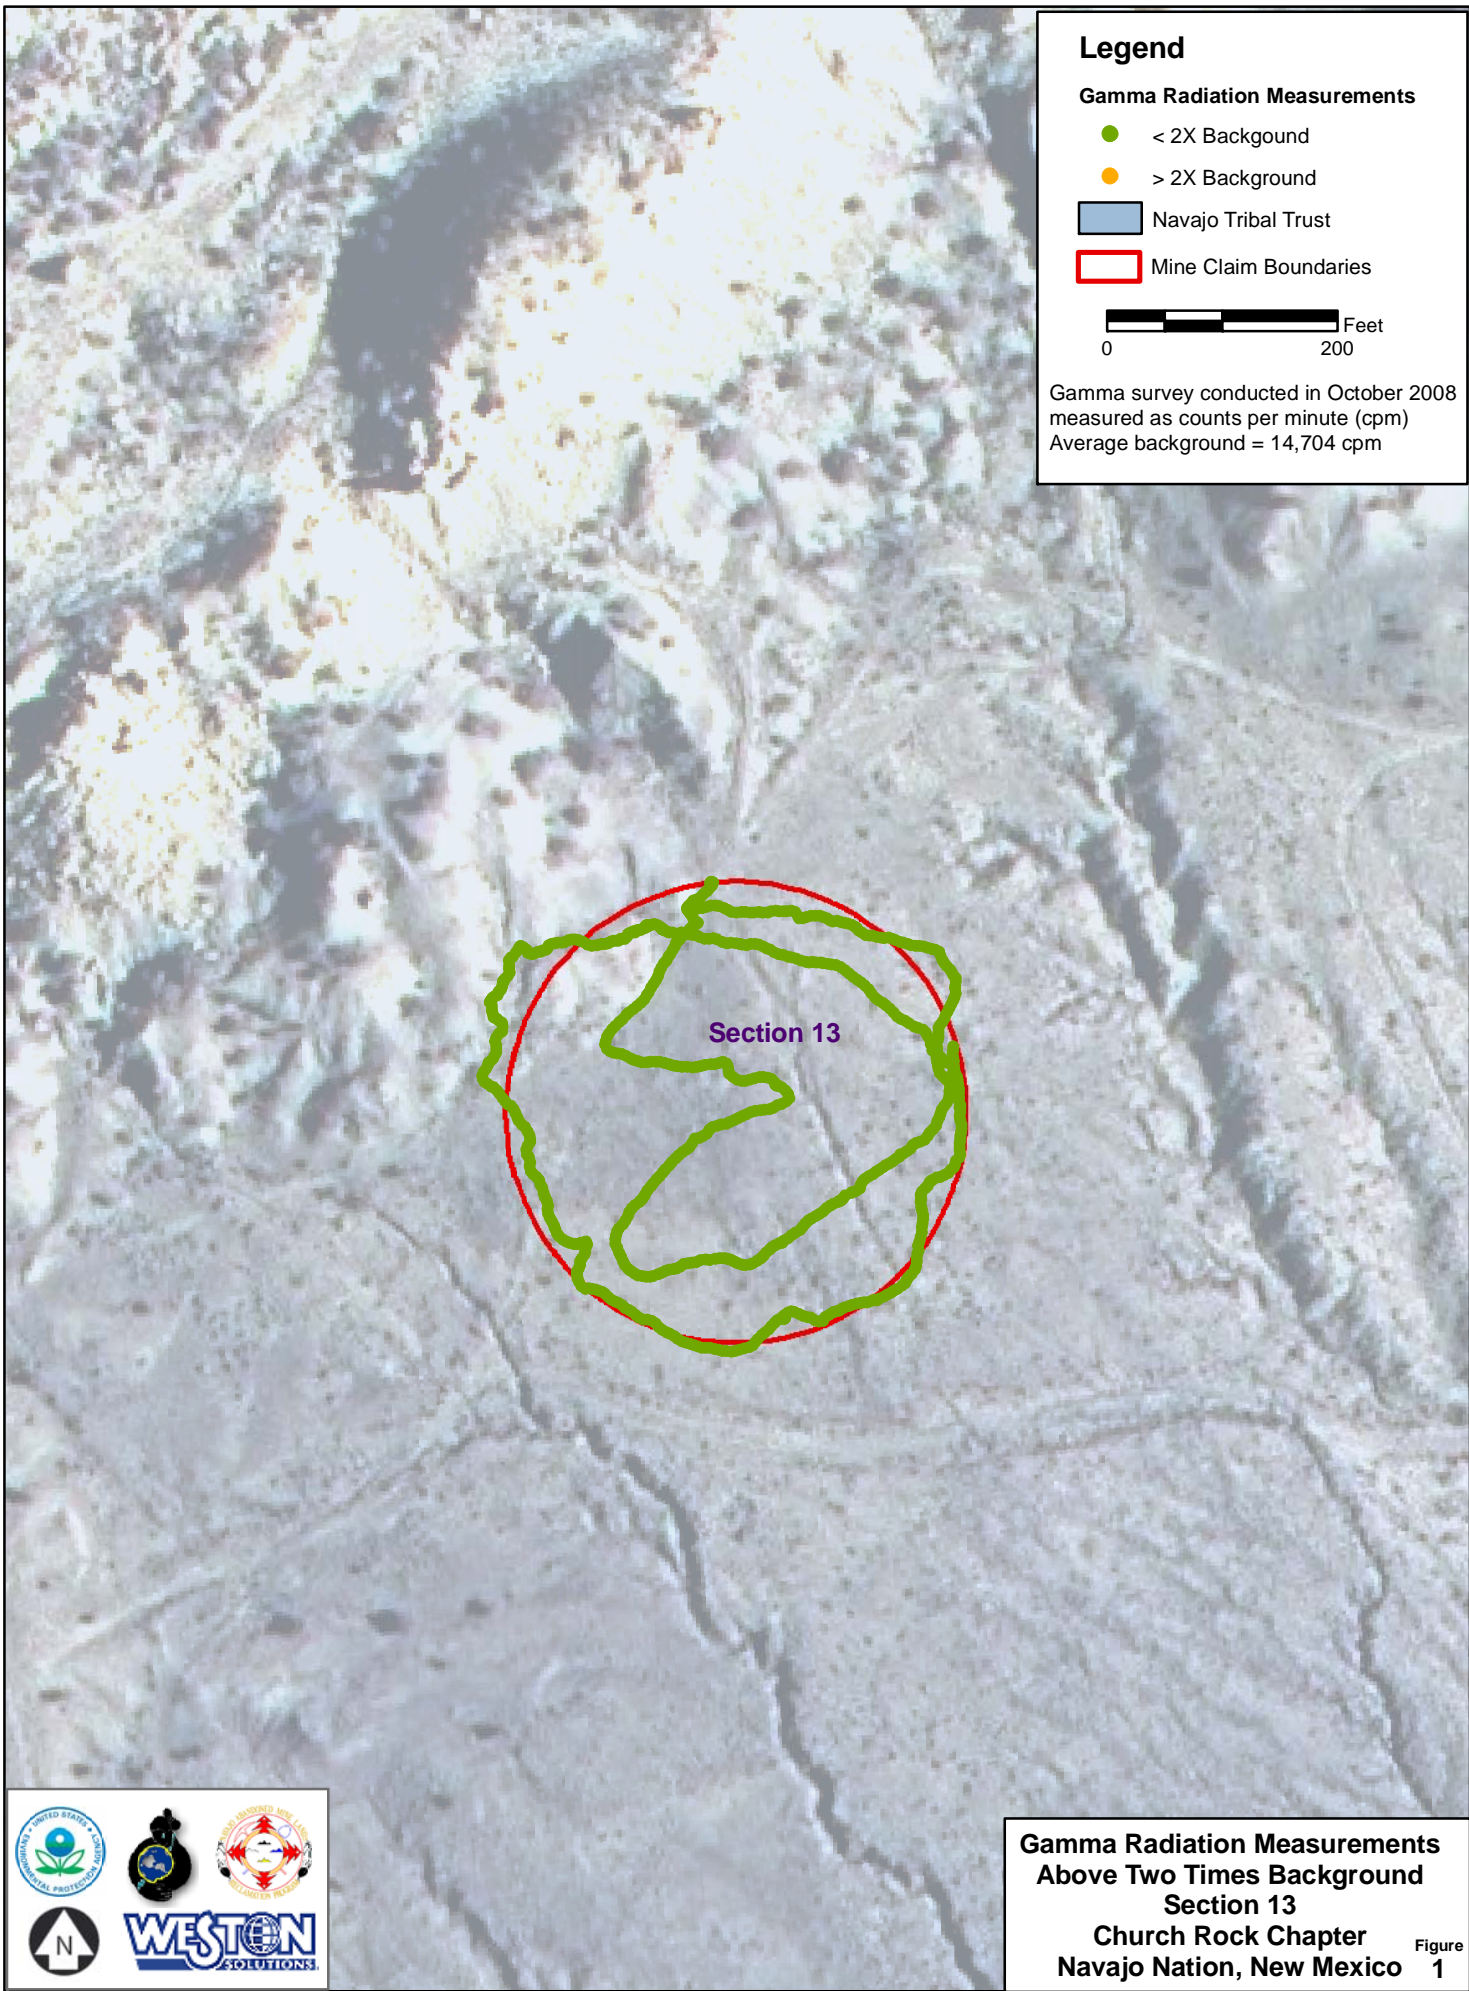
Figure
1

A total of 953 gamma radiation measurements were collected from mine sites, ranging from 11,796 cpm to 20,667 cpm. The measurements are represented in Figures 1 and 2.

Gamma survey conducted in October 2008
measured as counts per minute (cpm)
Average background = 14,704 cpm

**Gamma Radiation Measurements
Above Two Times Background
Section 13
Church Rock Chapter
Navajo Nation, New Mexico**
